# Study on Abnormal Vibration Cause and Blade Damage Fractal of Induced Draft Fan Burning Low-quality Coal

Huadian Xinzhou Guangyu Coal and Electricity Co., Ltd., Xinzhou City, Shanxi Province 034000, China

**Abstract:** With increasingly fierce competition in the electricity market and the gradual recovery of coal prices, the co-firing of low-quality coal is becoming increasingly popular among large-capacity thermal power units as a means to reduce fuel costs and improve economic efficiency. This study first conducted an abnormal vibration analysis of the induced draft fan blades in a thermal power plant that follows the principles of low-quality coal blending. The results are as follows: By recording vibration data inside the bearing housing during operation, it was found that severe bearing looseness caused excessive vibration. Upon disassembling the induced draft fan and inspecting its condition, it was discovered that, due to the high silicon and sulfur content in the low-quality coal, a significant amount of ammonium bisulfate crystals had formed on the hub. Additionally, the blades exhibited severe corrosion and wear, ultimately leading to dynamic imbalance and resulting v

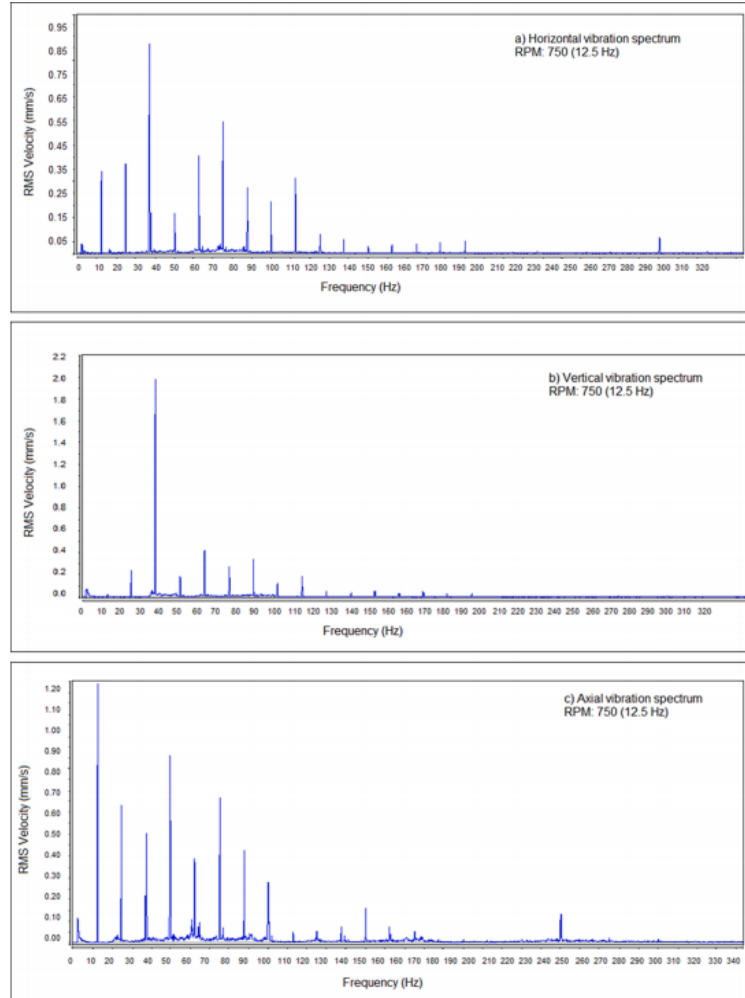
Figure 2. Vibration spectrum of bearing 3 in horizontal, vertical and axial directions

The acceleration signal is collected by VIBXpert instrument, the sampling is 4096 Hz, the sensitivity of the acceleration sensor is 100 mV/g, and the vibration spectrum of the horizontal, vertical and axial directions of the bearing 3 position is shown in Figure 2. It is found that the overall vibration level in the axial direction of the bearing is higher than that in the horizontal direction and vertical direction. When the speed of bearing C is 750 rpm at full load, the

operation of the fan blade is 12.5 Hz (750 rpm), and there are many peaks at the harmonics, and the phase presents unsteady characteristics; The presence of these harmonics indicates the existence of rotational loosening. An increase in vibration clearance is then observed at the bearing housing. This kind of vibration results in a significant increase in the blade vibration spectrum.

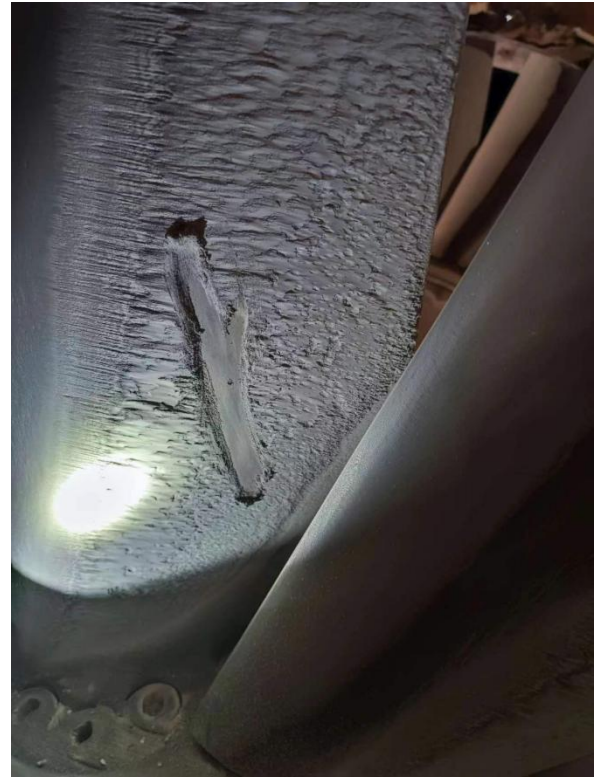
Figure 3. Impeller ash accumulation

The blending of low-quality coal in the unit caused ash accumulation in the impeller of the induced draft fan (see Figure 3). It can be observed in the picture that the thickness of the ash accumulation has exceeded 1mm. Moreover, the thickness of ash accumulation in the left area is quite different from that in the middle area, forming an obvious raised area. Low-quality coal generally has low calorific value, large ash content, and poor combustion efficiency. During the combustion process, a large amount of fine fly ash that is not completely burned out will flow through the impeller of the induced draft fan with the high-temperature flue gas. During the continuous operation of the fan, fly ash will gradually accumulate on the surface of each blade of the impeller, and due to the influence of flue gas deflection, blade wear differences, and fluctuations in combustion conditions, the thickness and distribution of ash accumulation are extremely uneven, and some blades have thick ash accumulation. Some blades accumulate less ash or even fall off locally, and the original precise dynamic balance state of the direct impeller. As a specific example (see Figure 3), with the duration of operation, the amount of ash accumulation accumulates, and the eccentricity difference of the impeller continues to increase, which eventually leads to the dynamic balance value of the fan rotor seriously exceeding the standard. After the dynamic balance exceeds the standard, there will be periodic abnormal vibration during the operation of the fan, which will not only aggravate the fatigue loss of the impeller, bearing, main shaft and hydraulic adjustment mechanism, cause uneven force on the blade, increase the impact load of the hydraulic rod, but also cause the temperature of the bearing. Problems such as rising and loosening of equipment fasteners further amplify the vibration defects and seriously threaten the safe and stable operation of the induced draft fan.

2) Maintenance personnel need to correct the dynamic balance on site after shutdown for maintenance or after the induced draft fan returns to the factory to eliminate the imbalance caused by wear, ash accumulation or thermal

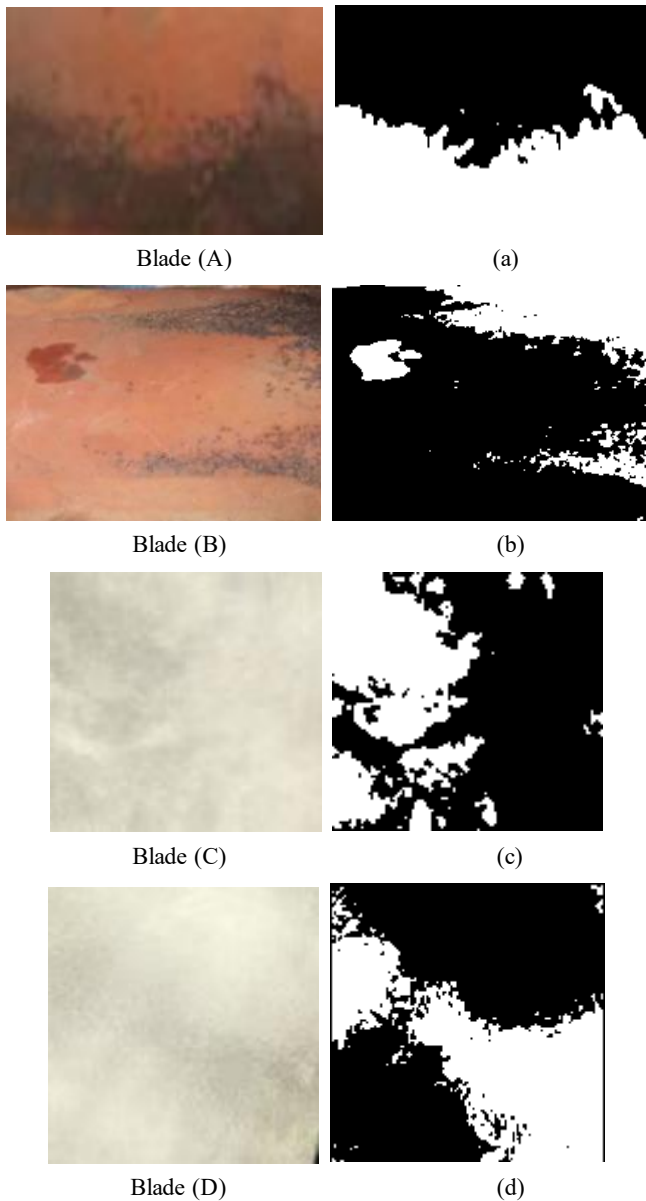
**Figure 4.** Threshold division under different blades

Observe that the pitting corrosion in Figure 4 (A) and Figure 4 (B) is more serious. Under normal circumstances, the maintenance personnel can observe the damage area of the blade with the naked eye. In the figure, obvious black and red areas are observed, and the black area is larger than the picture. Below is the pitting phenomenon caused by smoke corrosion

of the blade. The red area at the top of the picture is due to the red rust layer formed by the corrosion of  $\text{SO}_2$  and water vapor dew point in the flue gas. The difference between the two states is obvious, and the red domain is normal after the region is divided, which shows that the red rust layer is regarded as a normal region when calculating the box dimension, and only the pitting region is calculated. The overall threshold figure is consistent with the original figure. It shows that the pitting area can be clearly distinguished by using image j software. The wear conditions of FIGS. 4 (C) and 4 (D) are difficult to observe with the naked eye, wherein the blackened parts represent the areas worn by particles during blade rotation, and can be clearly distinguished after region division. The results show that the software threshold partition can distinguish the wear position effectively.

After dividing the threshold, the box dimension values of different blades are calculated and counted. In this paper, the  $\ln r$  of 9 box sizes (2, 3, 4, 6, 8, 12, 16, 32, 64) and the corresponding  $\ln N_r$  values of each blade are listed. It is found that the calculated values of blade A and blade B are larger than those of blade C at 0.69315 (the number of boxes is 2), and smaller than those of blade C at 4.15888 (the number of boxes is 64). The overall slope of blade A and B is larger, which corresponds to the fractal dimension value of blade A (1.887). The results show that pitting corrosion is more serious than blade wear.

According to the statistics of the blade fractal dimension in the two cases, (see Table 3) the blade A fractal dimension value is 1.887 compared with the blade B 0.024 (1.28%), and the blade C fractal dimension value is 1.528 compared with the blade D 0.048 (3.2%). It shows that the pitting corrosion and wear of the upper and middle parts of the blade are more serious than those of the lower and middle parts of the blade under the same working conditions. Maintenance and inspection of the middle and upper parts of the blades should be strengthened when the unit is undergoing major or minor repairs.

deformation. Regularly check the wear of blades, and repair or replace worn and deformed blades in time; Check the wear and clearance of the blade adjustment mechanism (such as the adjustment slider and push disk) to ensure that the blade angle is consistent and eliminate the local imbalance of the power field.
