# Study on Abnormal Vibration Cause and Blade Damage Fractal of Induced Draft Fan Burning Low-quality Coal

Huadian Xinzhou Guangyu Coal and Electricity Co., Ltd., Xinzhou City, Shanxi Province 034000, China

**Abstract:** With increasingly fierce competition in the electricity market and the gradual recovery of coal prices, the co-firing of low-quality coal is becoming increasingly popular among large-capacity thermal power units as a means to reduce fuel costs and improve economic efficiency. This study first conducted an abnormal vibration analysis of the induced draft fan blades in a thermal power plant that follows the principles of low-quality coal blending. The results are as follows: By recording vibration data inside the bearing housing during operation, it was found that severe bearing looseness caused excessive vibration. Upon disassembling the induced draft fan and inspecting its condition, it was discovered that, due to the high silicon and sulfur content in the low-quality coal, a significant amount of ammonium bisulfate crystals had formed on the hub. Additionally, the blades exhibited severe corrosion and wear, ultimately leading to dynamic imbalance and resulting v

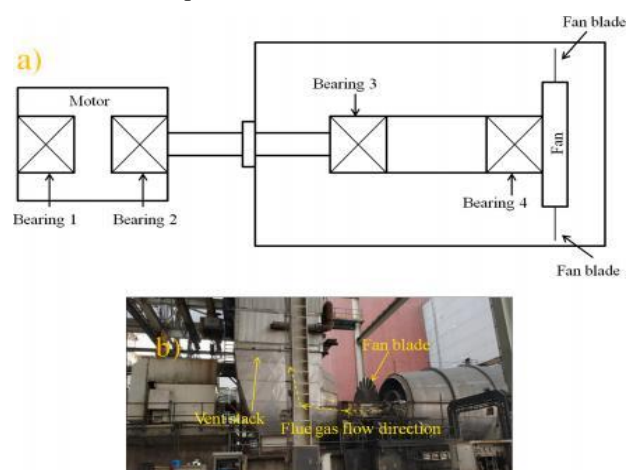
In the operation process, the vibration was measured under no-load condition and load operation condition of the whole plant respectively. The overall schematic diagram of the induced draft fan is shown in Fig. 1a, and the schematic diagram of the disassembled structure is shown in Fig. 1b. The vibration measurement range is all bearing positions (bearing 1-bearing 4 in Fig. 1a), and the vibration spectrum of the housing surface at the bearing 3 position is analyzed below as an example.

**Figure 1.** The overall schematic diagram of the induced draft fan is shown in Fig. 1a, and the schematic diagram of the disassembled structure is shown in Fig. 1b
